CASE FILE / DMM-SPECIMEN-01

# DAMP SURVEY REPORT.

24 Marchbank Road, Lincoln, LN2 4XG

Damp Survey

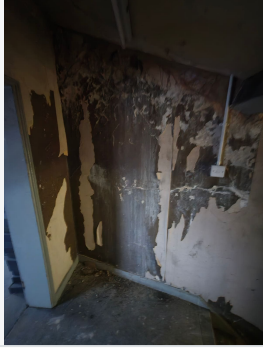
**AREA 01 LOUNGE, FRONT WALL****NOTE** RH 58 / TEMP 19.4 / WME 28

Tide marking and blown plaster are present along the front wall to a height of approximately 900mm, with a visible salt band at the upper edge. Moisture readings taken at 150mm, 500mm and 1000mm above floor level returned 28%, 19% and 12% WME respectively. The declining gradient is consistent with rising damp rather than a leak or condensation. The skirting board is soft to probe at its lower edge and will not survive removal intact. Decoration has been applied over the affected area at least twice.

- Once the external works are complete and the wall has dried, hack off the affected plaster on the front wall to 300mm above the highest tide mark and replaster using a salt retardant renovating plaster system. Standard gypsum plaster applied over salt contaminated masonry will fail.
- Where the slate damp proof course cannot be re-exposed, install a chemical injection damp proof course to the front wall in accordance with the manufacturer's instructions, followed by the replastering specification above.
- Renew the skirting boards to the lounge and hallway front wall, which are decayed at their lower edge and will not survive removal.
- Retrofit trickle vents to the front bedroom and bathroom windows to provide permanent background ventilation.

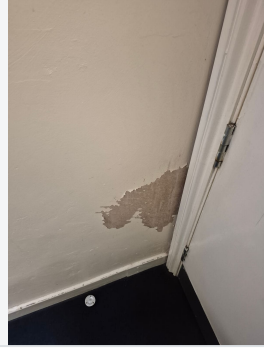
**AREA 02 HALLWAY****NOTE** RH 57 / TEMP 18.8 / WME 24

The same tide marking continues along the shared front wall into the hallway, at a slightly lower height of approximately 700mm. Readings peaked at 24% WME at skirting level. The floor covering was lifted at the threshold and the timber beneath was sound and dry, indicating the sub-floor void is still ventilating adequately.

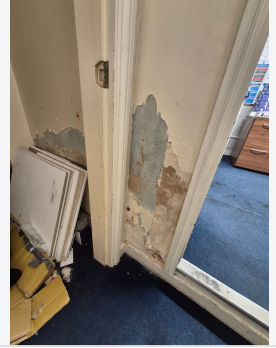
**AREA 03 KITCHEN, LEFT ELEVATION****NOTE** RH 61 / TEMP 19.1 / WME 31

A localised area of high moisture is present at high level on the left hand wall above the window, peaking at 31% WME. The affected area does not extend to floor level and is not continuous with the front wall dampness. Plaster is blown across an area of roughly 600mm by 400mm and salt deposits are visible at the margins. This pattern indicates water entering through the wall from outside rather than rising from the ground.

- Repair the failed gutter joint on the left elevation above the kitchen window, and check the full run for further defects while access is in place. This must be completed before any internal repair to that wall, or the damage will simply recur.
- Reduce the external ground level along the front elevation to re-expose the original slate damp proof course, achieving a minimum clearance of 150mm below it. Where the pavement cannot be lowered, form a drained channel against the wall to break the bridge.
- Install a mechanical extract fan to the bathroom, humidistat controlled and ducted to outside, sized to meet current Building Regulations Part F.
- Allow the affected walls a drying period after the external works are complete before any internal replastering is carried out. Replastering a wall that is still wet will trap the moisture behind the new finish.

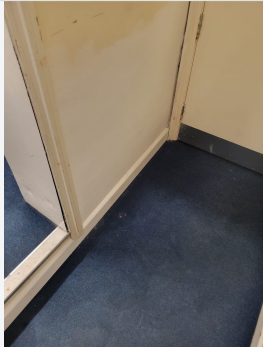
## AREA 05 FRONT BEDROOM

NOTE RH 64 / TEMP 16.9 / WME 15

Light mould growth is present on the outer wall behind the wardrobe and in the corner adjacent to the chimney breast. Both are cold spots with restricted air movement. Wall moisture readings were normal. The window shows no trickle vents and there was heavy condensation on the glazing at the time of inspection. This is a ventilation and cold bridging issue confined to the room.

- Leave a gap of at least 50mm between furniture and external walls, particularly the wardrobe in the front bedroom, so that air can circulate and the wall surface stays closer to room temperature.
