SPECIMEN REPORT

# MOULD REPORT.

8 Halstead Rise, Lincoln, LN6 3PW

Mould Inspection Report

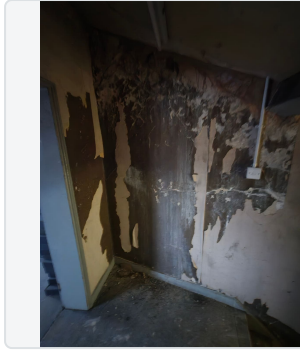
**AREA 01 REAR BEDROOM****NOTE** RH 68 / TEMP 15.9 / WME 14

This is the worst affected room. Mould growth is present across the north facing outer wall in a distinct horizontal band approximately 700mm wide, and more heavily in both corners and behind the chest of drawers. Surface temperature on the band measured 12.4 degrees against 15.5 degrees on the wall above and below it, a difference of 3.1 degrees. Wall moisture readings were normal at 14% WME, confirming the moisture is on the surface rather than within the wall. A clothes airer was in use in this room at the time of inspection. A young child sleeps in this room.

- Arrange a borescope inspection of the cavity in the north facing wall of the rear bedroom to confirm whether the insulation has slumped. If it has, the cavity should be re-filled by a suitably qualified installer. The 3.1 degree temperature differential recorded across that wall will otherwise continue to produce condensation in the same band every winter.

- Keep furniture at least 50mm clear of the outer walls, particularly the chest of drawers in the rear bedroom, so air can circulate behind it.
- Maintain a low, steady background heat rather than heating only in the evenings. Understandably this has a cost, and it is raised here because a cold wall will attract condensation no matter how well the room is ventilated. The ventilation and insulation works recommended above are intended to reduce how much this matters.

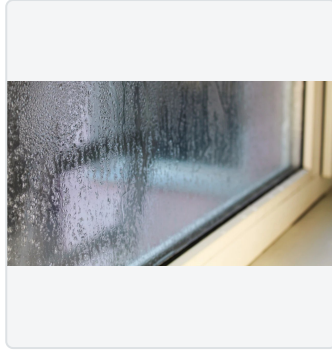
**AREA 02 FRONT BEDROOM****NOTE** RH 63 / TEMP 16.4 / WME 13

Mould growth is present to both window reveals and to the ceiling corner on the outer wall. It is lighter than the rear bedroom but clearly established. The window has trickle vents fitted but they were closed at the time of inspection. Wall moisture readings were normal throughout.

- Open the trickle vents in the front bedroom and leave them open through the heating season. They are fitted and closed, and they cost nothing to use.

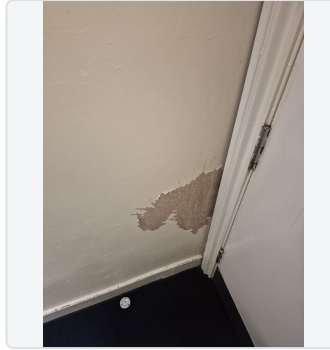
**AREA 03 BATHROOM****NOTE** RH 74 / TEMP 17.8 / WME 16

Relative humidity was recorded at 74%. Mould growth is present across the ceiling, to the window reveal and along the silicone seal at the bath edge. There is no mechanical extract fan fitted and no provision for one at present. The window is openable but was closed. Wall and ceiling moisture readings were within normal range for a bathroom in use.

- Install a humidistat controlled mechanical extract fan to the bathroom, ducted to outside and sized to meet current Building Regulations Part F. This is the single most effective intervention available at this property.

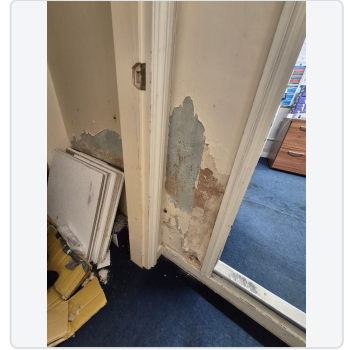
## AREA 04 KITCHEN

NOTE RH 66 / TEMP 18.2 / WME 15

Mould growth is present in the north corner and on the wall behind the washing machine, both cold and poorly ventilated positions. An extract fan is fitted above the hob but is not connected to any power supply and does not operate. Condensation was standing on the window at the time of inspection. Wall moisture readings were normal.

- Connect or replace the kitchen extract fan so that it operates. A fan that has never been wired in provides no benefit and gives a false impression that the kitchen is ventilated.
