MOULD REPORT

Lamb Gardens
Lincoln
LN2 4EG

09.02.26

Louis Walton FODSC
The Damp & Mould Man

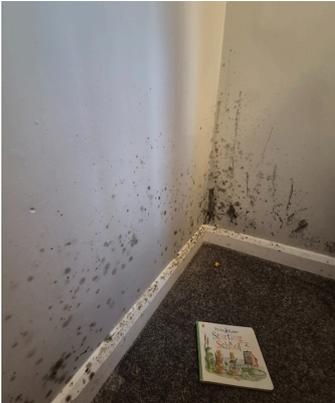
Playroom: 01

Moderate to significant mould growth is present in the playroom, front bedroom, and stairwell. The lounge and kitchen are currently unaffected, likely due to higher internal temperatures in these rooms.

Professionally clean all mould-affected areas using appropriate mould treatment products. Redecorate affected rooms following treatment and completion of structural improvements.

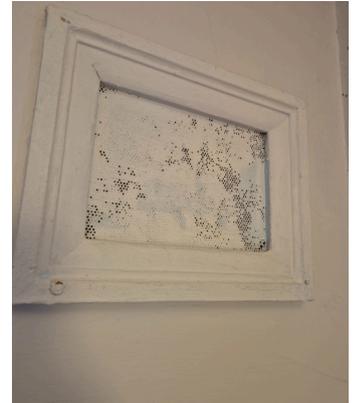
Playroom Vent: 04

Mould is currently affecting upstairs rooms and the hallway. The problem is seasonal and worse during winter months. Washing is dried on radiators throughout the property, with the tumble dryer located in an outhouse. There are no extractor fans in the kitchen or bathroom. Heating is used manually and intermittently. Windows remain shut overnight and during winter months. Moisture catchers are placed at every window. The air vent in the playroom has been painted over and is considered insufficient.

Install extractor fans in the kitchen and bathroom. The kitchen extractor should be humidity sensor activated to automatically remove moisture during cooking. Install a new air vent in the playroom to replace the painted-over unit. Install a trickle vent to the stairs window to provide background ventilation. Fit an internal door between the kitchen and lounge to contain cooking-related humidity. (Note: if installed without a kitchen extractor, mould may migrate to the kitchen/bathroom areas.)

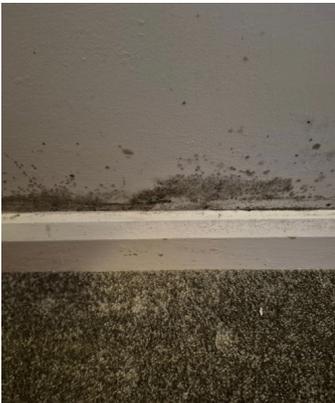
Playroom: 05

Water ingress from leaking wooden-framed windows is a secondary but significant factor. The wooden block sections at the bottom of the window frames are allowing water penetration, leading to sodden timber, rotting sills, and elevated localised moisture levels. This has directly contributed to the growth of *Penicillium* mould in the playroom.

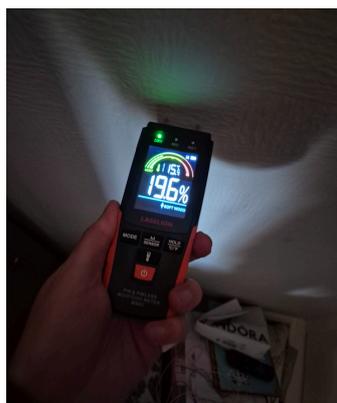
Wall Reading: 11

Area: Front Bed
Location: Ext wallpaper
Moisture Levels: 19%
Relative Humidity: 72.3%
Internal Temp: 13.0°C

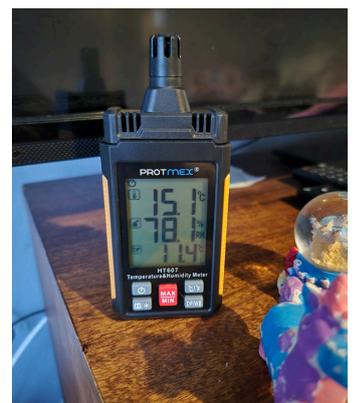
Kitchen Reading: 13

Area: Kitchen/Lounge
Location:
Moisture Levels:
Relative Humidity: 78%
Internal Temp: 15°C
